**Project “Pathway to the efficient use of local natural resources“**

# **Energy Efficiency Renovation and Air Quality**

**Kindergarten, Milot**

Author: Teuta Thimjo

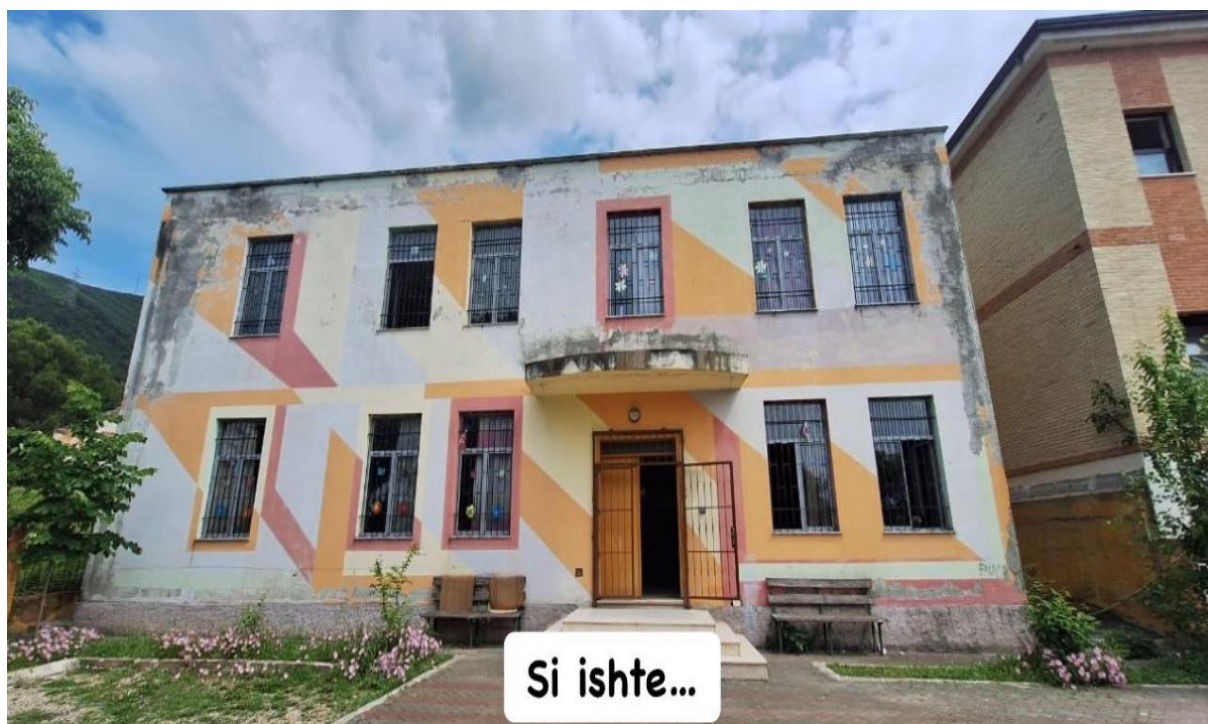
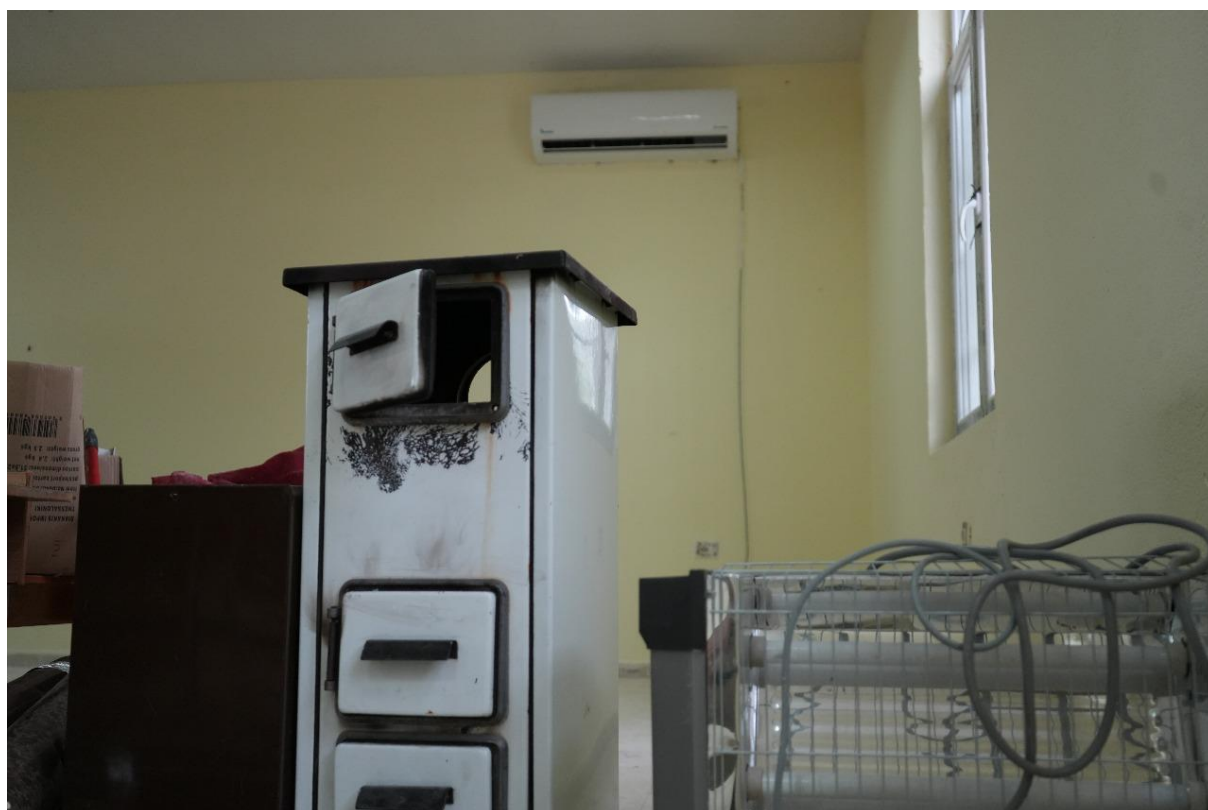
## 1. Technical Analysis of Pre-Renovation Inefficiencies

- The building envelope lacked insulation in exterior walls, attic, and floor slab. Likely U-values were  $>1.5 \text{ W/m}^2\text{K}$  for walls and  $>2.0 \text{ W/m}^2\text{K}$  for windows—well above modern energy codes.
- Heat transfer was dominated by **conduction** through uninsulated surfaces and **air infiltration** through joints and gaps.

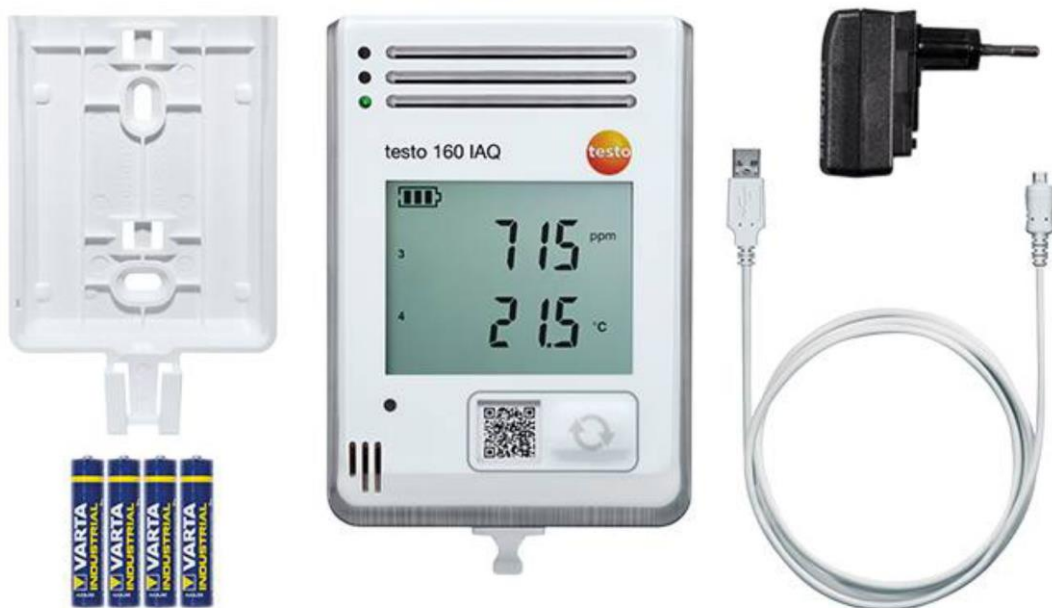
- 1- TESTO Brand Air Quality Meter  
Model 160 AQI WIFI
